Analytical Solutions

BN 1500

Stainless Steel Corrosion: Medical Device Applications with Auger Electron Spectroscopy (AES) Analysis

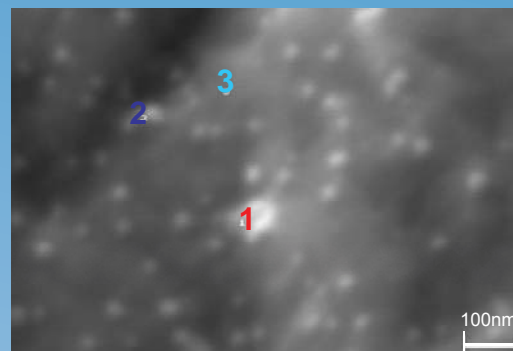
Figure 1 shows a high magnification secondary electron micrograph (100,000X magnification) obtained from an Auger instrument on the as-received surface of a piece of 300 series stainless steel sheet. The micrograph shows a series of extremely small defects, most of which being only about 25nm in diameter. This SEM image was used to define points on which Auger electron spectroscopy was to be performed. One large and one small particle (points 1 and 2, respectively) were analyzed along with a control region (point 3) off of the defects. All three of the survey spectra show the presence of the expected C, O, Cr, Fe and Ni from the air-exposed stainless steel surface. In addition, the spectrum from point 1 (larger defect) shows the presence of a large amount of Ca along with a smaller Na peak. The Auger spectrum from the small defect (point 2) shows the presence of S and Na contaminants but also shows much different Fe to Cr peak ratios than the spectrum from the control area (point 3). Quantification of the elements detected from these three points is shown in Table 1. Auger maps were acquired for several of the elements of interest including Ca, Cr, and Fe. The map for Ca reveals a lateral distribution of Ca within a 1mm² field of view

Although scores of particle defects were observed in the SEM image, only a few of them appear to have significant Ca, as shown in the Ca Auger map. Most of the smaller particles correspond to larger concentrations of Fe, compared to the background area (Point 3). This indicates that localized corrosion has occurred within these 25nm-sized defects with an obvious potential cause being the presence of Na.
